MARINE CASUALTY REPORT.

SS KEYTRADER AND SS BAUNE (NORWEGIAN)

COLLISION IN THE MISSISSIPPI RIVER ON

18 JANUARY 1974 WITH LOSS OF LIFE.

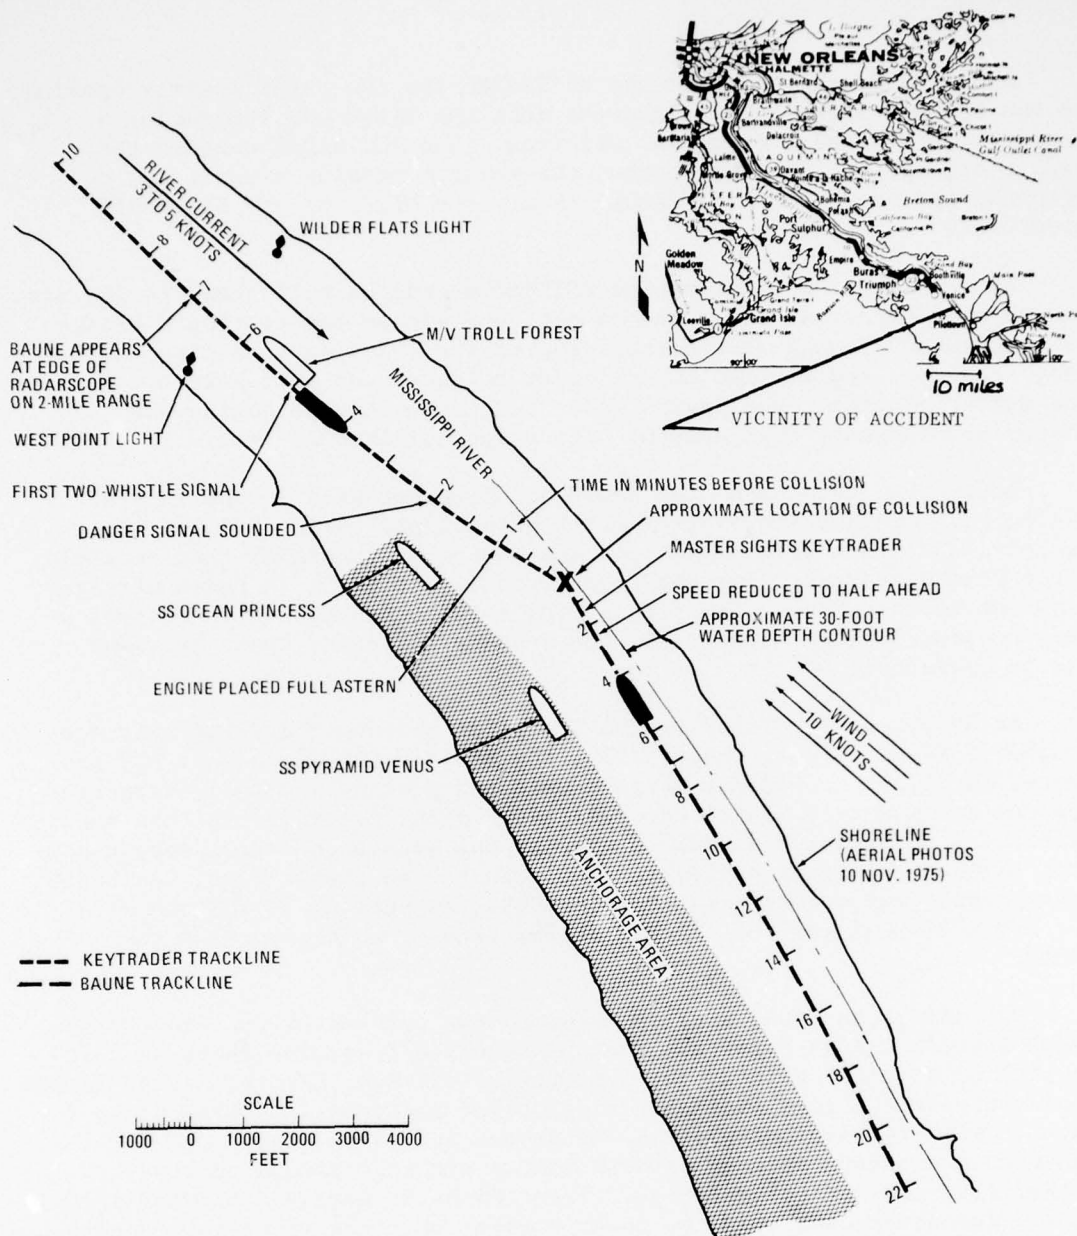
FIGURE 1. PROBABLE TRACKLINES OF KEY TRADER AND BAUNE PRECEDING COLLISION

About 1355, the KEYTRADER passed between the anchored M/V TROLL FOREST and the west bank. (See figure 1.) The TROLL FOREST was anchored approximately 1,800 feet below the West Point light, and between 1,200 and 1,500 feet off the west bank. The KEYTRADER passed approximately 300 feet abeam of the TROLL FOREST. About this time, the master and pilot observed--first on radar and then visually--three vessels, which appeared to be in an anchorage area. They determined that two of the vessels were anchored. The SS PYRAMID VENUS was anchored about 1.5 nmi downriver from the West Point light and about 1,650 feet off the west bank. The SS OCEAN PRINCESS was anchored about halfway between the TROLL FOREST and PYRAMID VENUS and closer to the west bank than the PYRAMID VENUS. Further radar and visual observations of the third vessel, the SS BAUNE, which was eastward of the first two vessels, confirmed that it was underway. Just after passing the TROLL FOREST, the KEYTRADER began to alter course several degrees to port to avoid the ships in the anchorage area.

The Safety Board constructed probable tracklines for the KEYTRADER and BAUNE (See figure 1.) The tracklines show the approximate locations of both vessels at certain times as they proceeded toward the point of collision. The approximate positions of certain anchored vessels were also determined. Accuracy in determining the tracklines was limited by the readability of the ships' course recorders, the reliability of testimony from the ships' crewmen, and the estimated speed of the river's current. The Safety Board has recommended previously that the Coast Guard require the installation of an automatic recording device to preserve vital navigational information aboard oceangoing ships. ^{3/}
